**NANOFOCUS X-RAY COMPUTED TOMOGRAPHY AND ULTRASONIC INSPECTION OF
BARELY VISIBLE IMPACT DAMAGE IN CARBON FIBER REINFORCED POLYMERS**

Elliott Jost¹, David Moore
Sandia National Laboratories
Albuquerque, NM

ABSTRACT

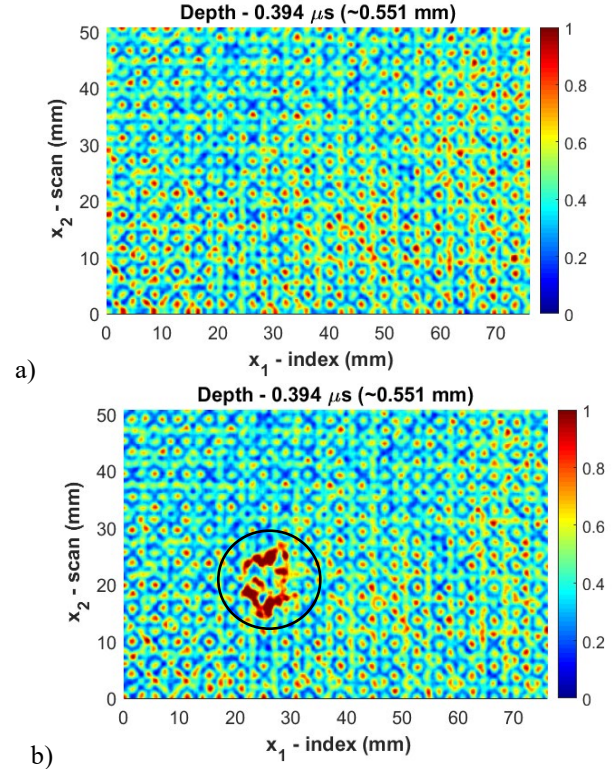
A comparison of pre- and post-impact ultrasonic inspection results can be seen in Figure 1 at approximately 0.551 mm into the ~3 mm thick specimen, as seen from the tool side.

FIGURE 1: A) PRE-IMPACT ULTRASONIC C-SCAN. B) POST-IMPACT ULTRASONIC C-SCAN WITH IMPACT AREA CIRCLED

It is visually apparent that there is impact damage detected in the post-impact ultrasonic c-scan, as highlighted in Figure 1b. Damaged region area was calculated throughout the c-scan for each image and damage areas were calculated for each ply. Ultrasonic damage analysis was conducted in MATLAB.

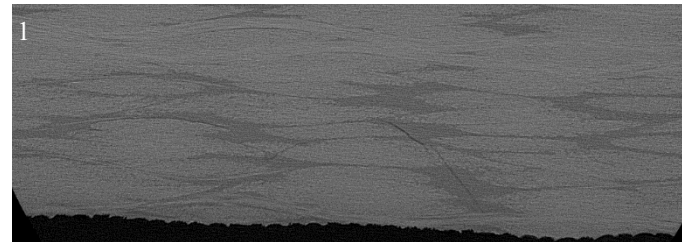
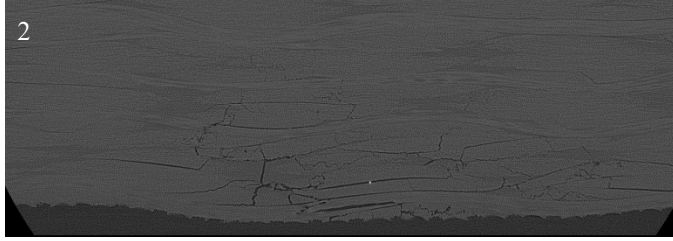
Analysis of the collected CT inspection data revealed the presence of delamination and matrix cracking in the impacted CFRP's. Figure 2 shows parallel slices from damage induced in specimen 2. Delaminations are horizontal cracks separating tows of fibers from the resin matrix. Matrix cracks are vertical cracks in the resin matrix. Microcracking shown in Figure 2 could be detected on the Nanofocus CT system but not the microfocuss system, emphasizing the challenges present in accurately measuring and inspecting BVID in composites.

FIGURE 2: SAMPLE 2 NANOFOCUS COMPUTED TOMOGRAPHY SLICES FROM SAMPLES 1 AND 2 SHOW DELAMINATION AND MATRIX CRACKING.

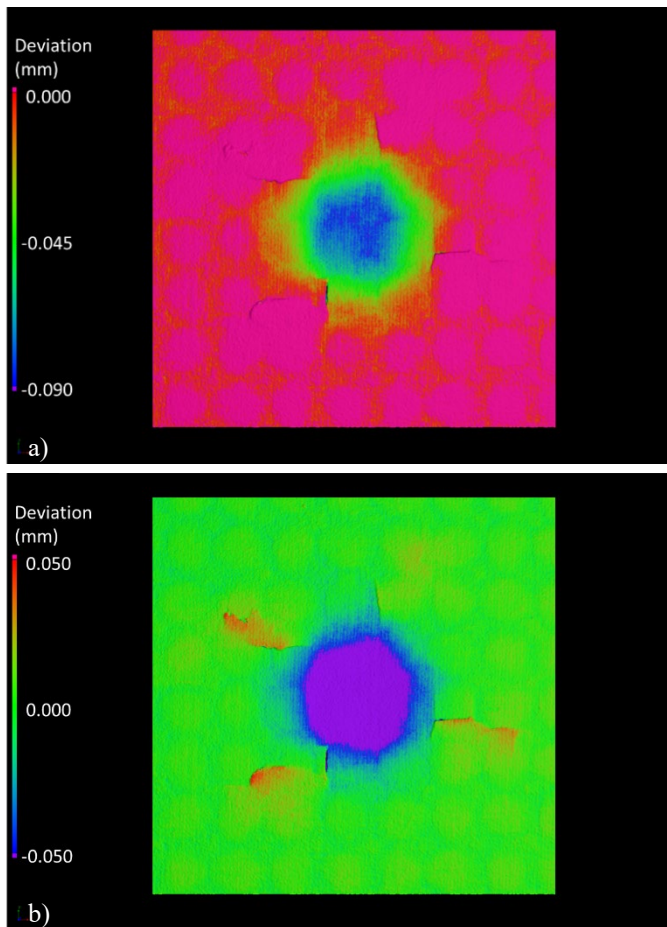
Indent depth, an important measure in composite impact damage, was measured by comparing a virtual plane to the damaged plane of the CT scan. The plane was calculated by using several distributed fit points from un-impacted areas on the surface of the CT data sample. Results are shown in Figure 3 where positive deviations are in excess of nominal geometry and negative deviations are indentations. Figure 3a shows the impact indent to be predominantly circular and 0.088 mm deep at the deepest point. Figure 3b shows positive deviations in red due to surface cracks extending from the impacted area.

FIGURE 3: DAMAGED REGION DEVIATION MAPPING OF SAMPLE 2. A) SCALED TO SHOW INDENT DEPTH. B) SCALED TO SHOW SURFACE CRACKS
