Martempering to Improve Wear Properties of Aircraft Brake Steel Rotors

By Dr. Sudershan Jetley

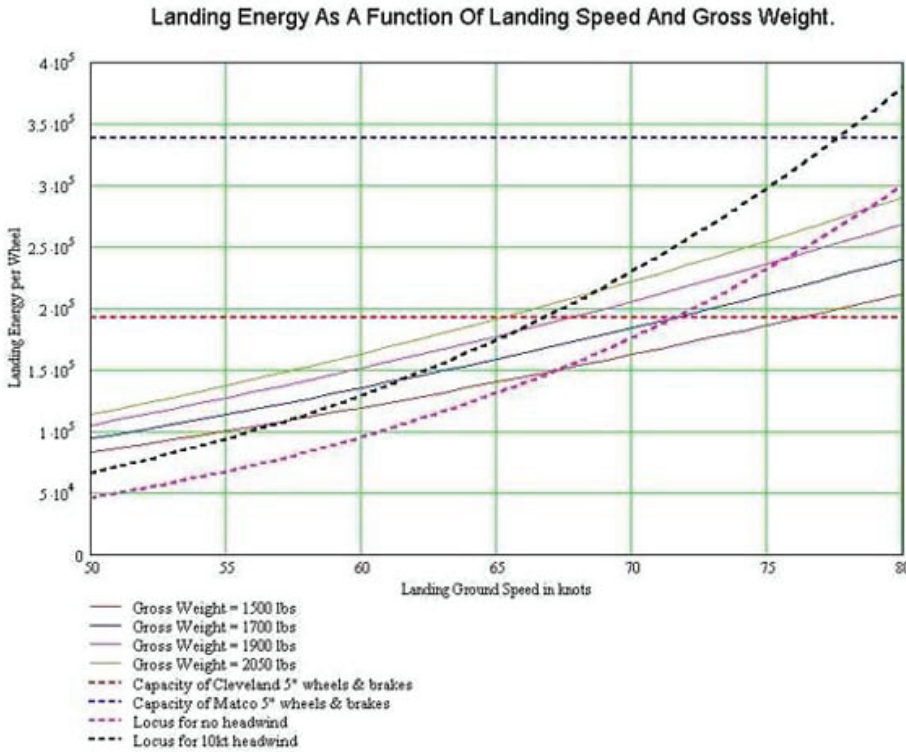
Figure 1. Effects of Speed and Weight of aircraft on Landing Energy Per wheel (Johnson, 2006)

From these relationships, it can be seen that for a given aircraft, speed and weight are the governing factors in brake design. This is again seen in graphical form in figure 1.

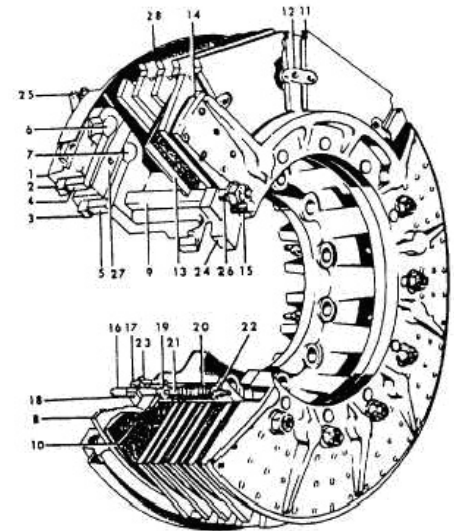
1. Carrier assembly
2. Piston cup (outer)
3. Piston cup (inner)
4. Piston (outer)
5. Piston (inner)
6. Piston end (outer)
7. Piston end (inner)
8. Pressure plate
9. Stator drive sleeve
10. Auxiliary stator and lining assembly
11. Rotor segment
12. Rotor link
13. Stator plate
14. Backing plate
15. Torque pin
16. Adjuster pin
17. Adjuster clamp
18. Adjuster screw
19. Adjuster washer
20. Adjuster return spring
21. Adjuster sleeve
22. Adjuster nut
23. Clamp hold down assembly
24. Shim
25. Bleeder screw
26. Drive sleeve bolt
27. Dust cover (inner)
28. Dust cover (outer)

Figure 2. Segmented rotor brake—cut-away view.

Pre World War II, the landing gear of aircraft was not retracted and stowed. However, with increased speed requirements it became necessary to retract and stow the landing gear to reduce drag. To meet these requirements, wheels became smaller to reduce stow space, leading to the development of multiple disc brakes (Aircraft Technology Engineering and Maintenance, 2000). This design has become standard and all large planes today use the multiple disc brakes. An example diagram of these brake assemblies is shown in figure 2 (Integrated publishing, 2006).

The essential part of the brake assemblies is a rotor rotating in contact against a stationary stator during braking. The industry primarily uses sintered, copper based alloys as stators and steel rotators.

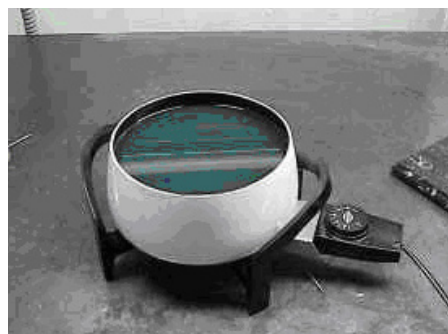
An electric pot with a temperature setting control was used to quench the pucks. The electric pot is a domestic kitchen pot and has a half gallon holding capacity. The temperature range on the pot is 0° to 400° F. The temperature control was used to set the quenchant temperature and a ‘Suregrip’ thermocouple temperature probe was used to actually monitor the quenchant temperature. This probe has a temperature range of -40°F to 1994° F. Figure 7 is a photo of the electric pot.

Figure 7. Electric Pot

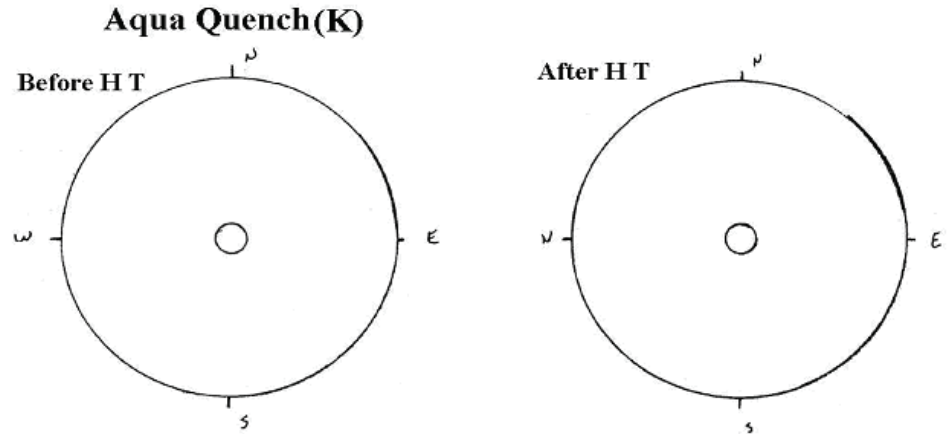
The visual error in the procedure of comparing the two tracings can be said to be half of the pencil line width, so it is in the order of 0.5 mm. Since the diameter of the puck was about 65 mm, the measurement error translates to 1.54 %. (1mm/65mm * 100 = 1.54). An example of the tracing is shown in figure 9.

Figure 9. Example of a tracing to determine radial distortion

To assess any distortion in the radial direction, each puck was traced on a sheet of graph paper, and then retraced after it had been heat treated and tempered. Transparencies of the after heat treatment traces were overlaid on the traces of the before heat treatment traces to evaluate any differences. Parts labeled K, P, E and R were used for oil quenching and those labeled Q, M and T for aqua quenching.

Although radial distortion is not of much importance in the functioning of the pucks, an attempt was made to measure this. As has been stated, the ideal method for measuring radial distortion would have been to use a profilometer or a CMM. In absence of such apparatus the above described tracing method was used. In all the eight parts used, no radial distortion was detected. An estimate of the accuracy of this method can be obtained as follows:
