Title: UHPC Used to Repair Bridge Pylons after Delayed Ettringite Formation

The Bourgogne bridge crosses the “Saône” river in France since 1992. The deck is supported by cable stays and two lyre shape pylons. Only 6 years after commissioning, an important number of cracks appeared on both pylon bases (dimensions 7,65-yard x 2,18-yard x 13,38-yard). After several years of investigations, it was concluded the pathology was linked to a Delayed Ettringite Formation (DEF) which only affected the pylons’ bases. The expansion of the pylons’ bases was monitored for 15 years until the experts agreed that there was no further evolution. Three solutions have been designed to repair the pylons’ bases: cracks injection and carbon fiber strengthening, PT strengthening with reinforced concrete protection and finally a 3,94-in thick reinforced UHPC shell. The UHPC solution has been selected to ensure a waterproofing effect and long-term protection of the existing rebars. The choice was made to cast in place the UHPC to enhance the pylon’s base capacity. The first challenge was to produce the UHPC near to the pylons without impacting the road traffic on the bridge: a dedicated floating platform ha

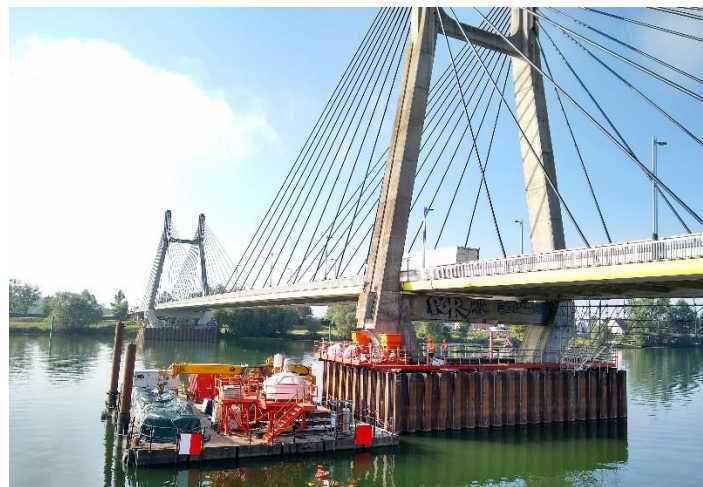
Figure 1: General view: pylon base repairing works

One of the challenges was to produce the UHPC near to the pylons without impacting the road traffic on the bridge: a dedicated floating platform has been developed to facilitate the production. The contractor equipped it with a crane, a mixer to reduce time transportation between the production site and the worksite. The area around the pylon was dewatered using sheet piles to create a safety zone for the workers, but the space was limited to reduce the impact on the river traffic. A scaffolding system was built all around the pylons' bases to facilitate the different operations.

One of the difficulties was to avoid bars from the formwork inside the shell of UHPC to ensure a good waterproofing capacity of the shell. The company stabilized the formwork with struts that can be moved using a chain hoist before each stage of pouring.
