Evaluation of UHPC as a Repair Material for Corroded Steel Bridge Girders

Kevin F. McMullen¹ and Arash E. Zaghi, Ph.D., PE, SE²

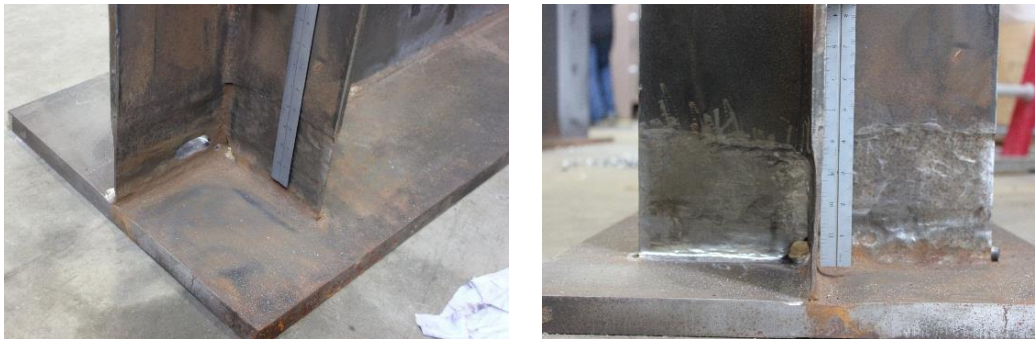
Figure 2: Simulated corrosion damage

Simulated section loss was applied to the web and bearing stiffeners at the girder end of all four plate girders as shown in Figure 2. The target minimum section loss was 66% reduction of the 0.375-in. (9.5-mm) web and 50% reduction of the 0.5-in. (13-mm) bearing stiffeners. The level and pattern of corrosion damage implemented was based on observations from inspection reports of structurally deficient steel bridges in Connecticut.

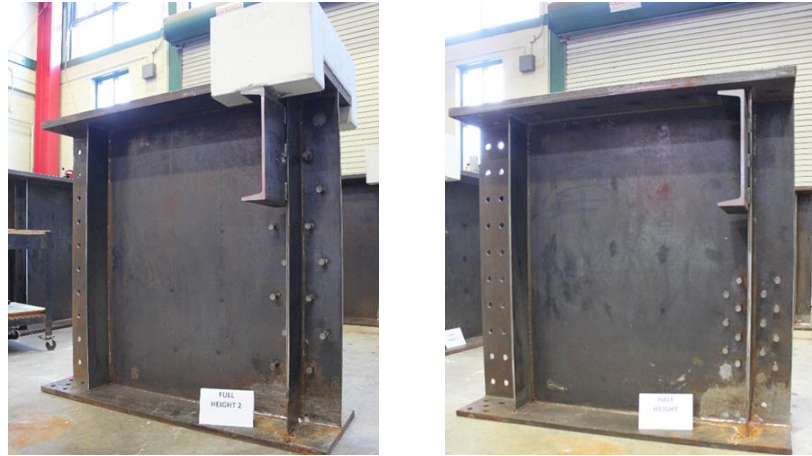
Figure 4: Final shear stud configuration: a) Full Height 2; b) Half Height

The UHPC repair was implemented under conditions representative of those that would be experienced in the field. The final shear stud configuration of the Full Height 2 and Half Height repairs are shown in Figure 4. The studs were welded to the web of the girder according to standard field welding practices by a certified iron worker.

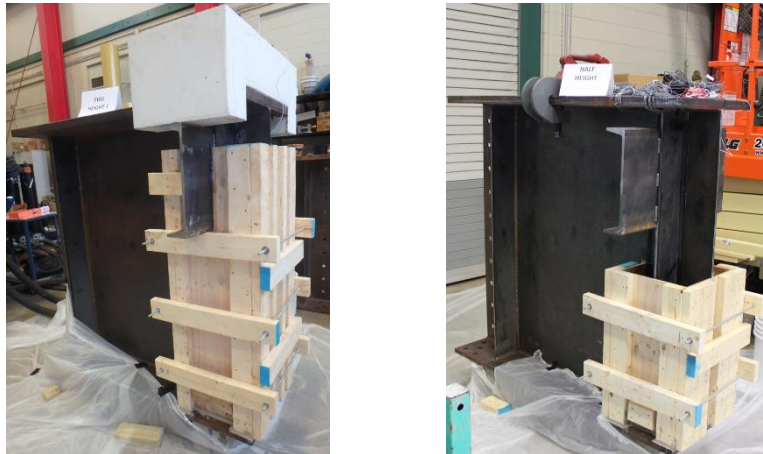
Figure 5: Formwork for UHPC panel: a) Full Height 2; b) Half Height

The formwork used for casting of the UHPC panels is shown in Figure 5. Standard plywood formwork was used for construction of the panels. The formwork could be customized to account

for obstructions at the girder end such as end diaphragms or deck haunches. The formwork was attached to the plate girder with epoxy and secured with threaded rods. The threaded rods were passed through holes drilled in the web of the girder to clamp the formwork on either side of the web. The formwork was designed to be water tight because of the rheological properties of the UHPC material. Gaps in the formwork were filled with construction caulk.

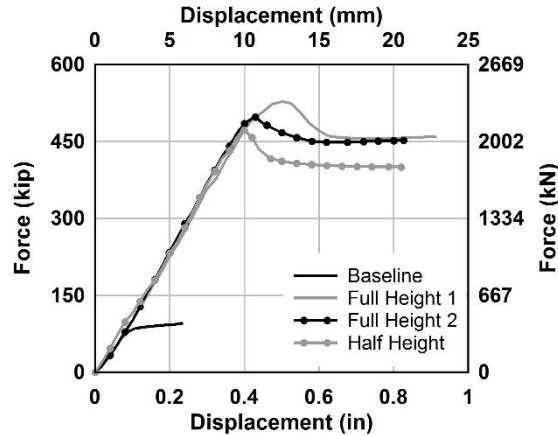
Figure 7: Bearing force vs. mid-span displacement

The bearing force versus mid-span displacement response for the four experimental plate girder tests is shown in Figure 7. The baseline damaged girder failed due to localized buckling of the damaged region of the web and stiffener. The simulated section loss introduced to the girder significantly reduced the bearing capacity of the specimen. No damage was found outside of the corroded region of the girder end. This localized buckling failure is consistent with observations in the field when girders experience severe corrosion damage.

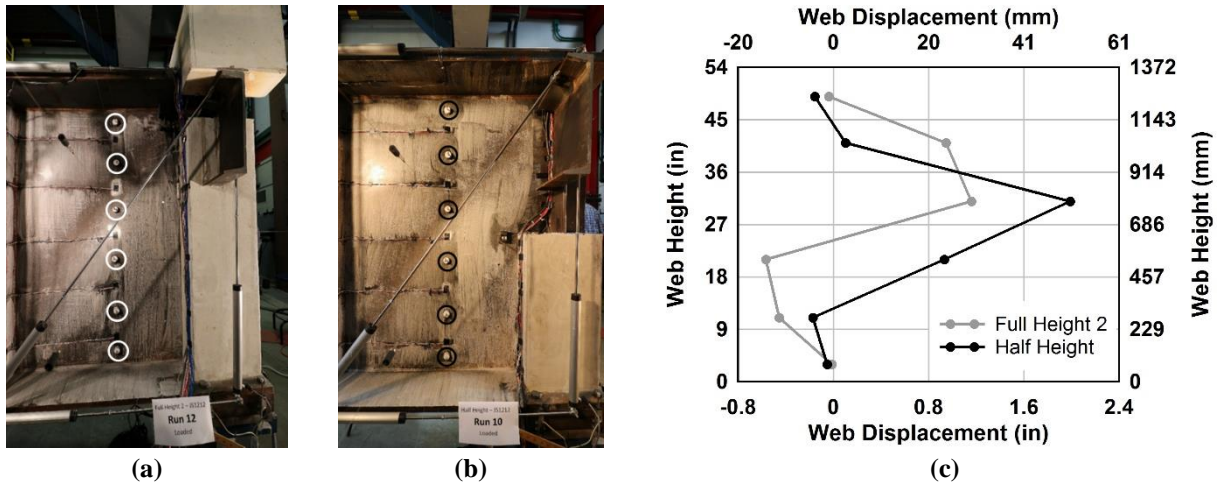
Figure 8: Plate girder failure modes: a) Full Height 2; b) Half Height; c) Web height vs. web displacement

Typically, the design failure mode for stiffened web plate girders is shear buckling of the end panel. The web of the end panel fails with a half sine wave buckled shape. The failure modes of the Full Height 2 and Half Height repaired girders are shown in Figure 8. All three repaired girders failed due to shear buckling of the end panel. The Half Height repaired girder failed with a half sine wave buckled shape similar to the design failure mode. However, the two full-height

girders had a full sine wave buckled shape. This was caused by the additional bracing provided by the full-height UHPC panel on the web of the girder. The UHPC panel stiffened the end panel, which increased the buckling capacity and forced the failure mode to shift to second mode buckling. The capacities of the Full Height 1 and Full Height 2 repaired girders were approximately 12% and 5% larger than the Half Height repaired girder, respectively.

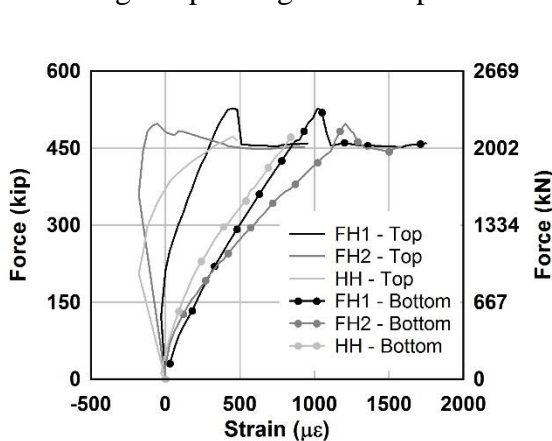
Figure 9: Bearing force vs. axial stud strain

Axial strain gauges were imbedded in seven shear studs within one of the columns of studs to analyze the force transfer from the web of the girder through the studs. The bearing force vs. axial stud strain relationships for the top and bottom studs for all three repaired girders are shown in Figure 9. The results showed that the studs at the bottom of the repair were activated first. As the demand on the repair increased, the forces in the studs redistributed and the studs at the top of the repair were activated. For both the Full Height 1 and Full Height 2 repairs, the studs at the top

of the repair experienced significant yielding. However, the studs in the Half Height repair experienced minimal yielding with negligible permanent deformation.

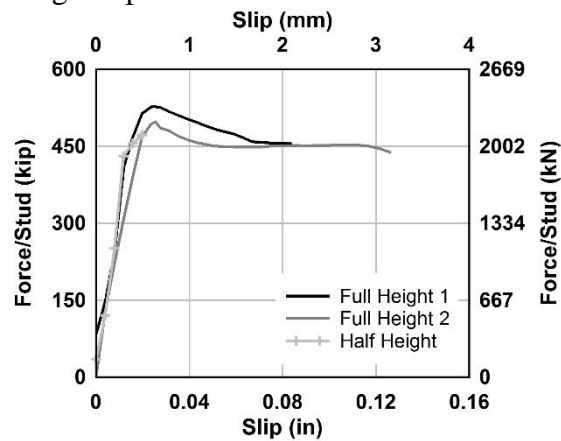
Figure 10: Bearing force vs. UHPC panel slip

The relationship between the force per stud and the slip between the web and UHPC panel was analyzed to investigate the demand on the shear studs for each of the repairs. Kruszewski et al. (2018a) determined that shear failure of the studs occurred at panel slips between 0.157-0.197 in. (4-5 mm). The force versus slip relationship for all three repaired girders is shown in Figure 10. The Full Height 1 and Full Height 2 repaired girders experienced maximum panel slips of 0.116 in. (2.94 mm) and 0.127 in. (3.22 mm), respectively, which corresponded to approximately 70-80% of the maximum slip capacity of the studs. Conversely, the Half Height repaired girder experienced a maximum panel slip of 0.021 in. (0.53 mm), which corresponded to 13% of the maximum slip capacity of the studs. This indicates that significantly less demand was placed on the half-height repaired girder compared to the full-height repairs.
