Implementation of UHPC for the Repair of a Steel Bridge with Corrosion Damage in Connecticut, USA

Keywords: Corroded Steel Girder Ends, Repair Method, Repair Design, Field Evaluation

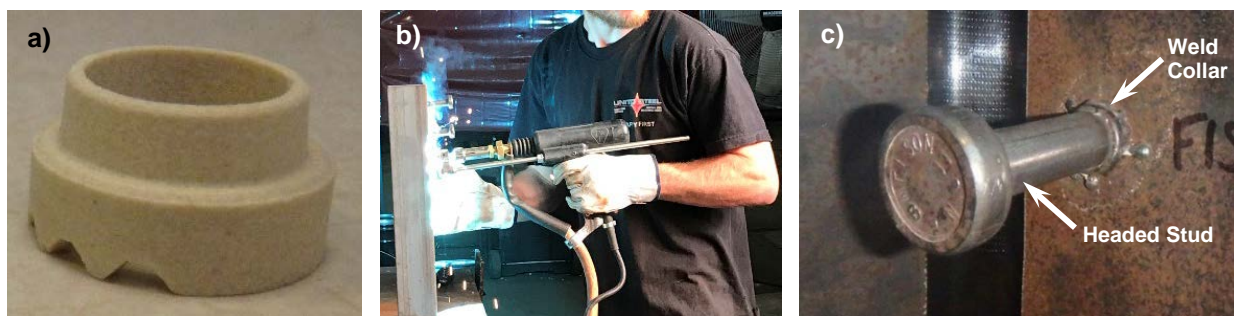
Figure 3. Welding of headed shear studs including a) ferrule, b) welding on a vertical plate, and c) finished product.

To respond to this crisis, the Connecticut Department of Transportation (CTDOT) has pioneered the development of an alternative repair strategy by supporting a promising research project at the University of Connecticut (UConn). A repair concept using ultra-high performance concrete (UHPC) was investigated through a two-phase research project. In Phase I, the applicability of the repair method as a structurally effective and practical alternative repair strategy to restore the capacity of corroded beam/girders was investigated (Zmetra et al. 2015; Esmaili Zaghi et al. 2015; Zmetra et al. 2017; Zmetra 2015). The proposed repair involves casting UHPC around the corroded steel section. The UHPC is connected to the intact portion of the web via shear studs. A schematic of the repair is shown in Figure 2. Details of welding the shear studs using a stud gun are shown in Figure 3.

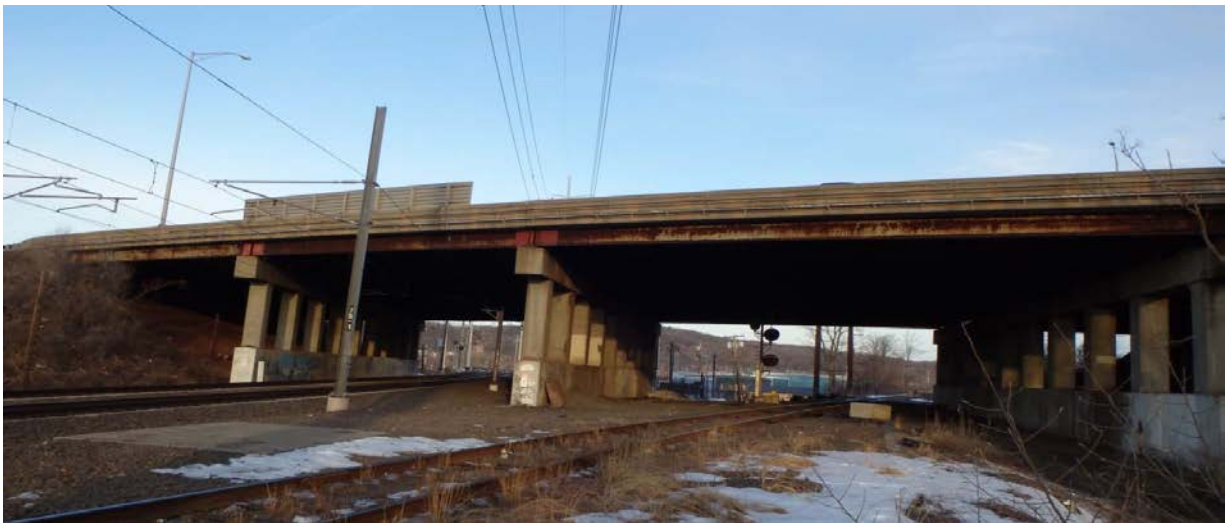
Figure 5. Image of bridge in New Haven, CT scheduled to undergo UHPC repair at beam ends.

The bridge scheduled to be repaired is a rolled steel beam and concrete deck structure consisting of four simple spans with a total length of 273 ft (83.2 m). The beams have partial length cover plates welded to the bottom flange. The beams have variable sizes with heights ranging from 33-36 in (838-914 mm) and different end conditions (with and without bearing stiffeners). The reinforced concrete deck is composite with the steel beams. The bridge carries Interstate 91 in New Haven and spans three Amtrak tracks. The structure was originally constructed in 1965. The plan view of the bridge is shown in Figure 4 and an image of the structure is shown in Figure 5.

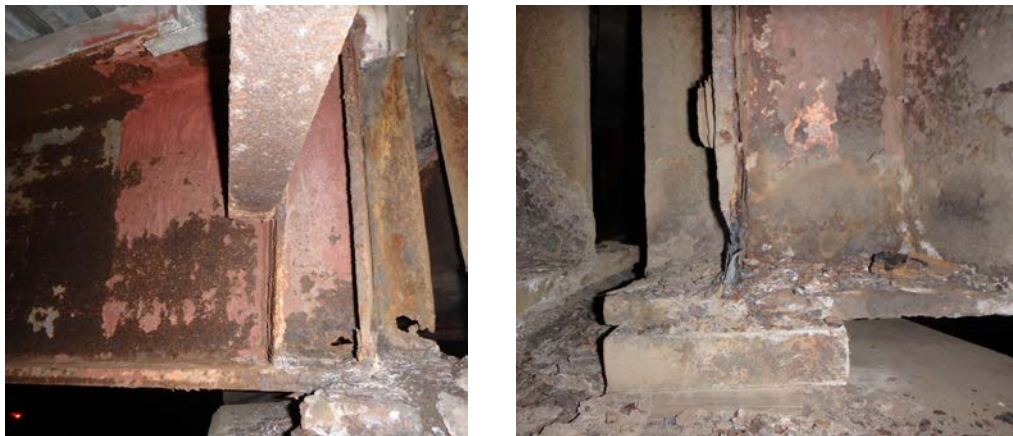
Figure 6. Representative beam end corrosion on the bridge

The bridge was rated as structurally deficient during the inspection and evaluation performed in 2016. All beam ends have rust, peeling paint, and areas with laminar rust (Figure 6). Web ends and bearing stiffeners have substantial section loss, resulting in reductions in the bearing and shear capacities. The maximum reductions in bearing and shear capacity according to the 2018 inspection report were 72% and 15.5%, respectively. Over 50% of the paint on the structure is

deteriorated. The end diaphragms and corresponding connection plates have areas with laminar rust, section loss, and perforations.
