QUANTITATIVE EVALUATION OF HYPERVELOCITY DEBRIS CLOUD-INDUCED PITTING DAMAGE USING NONLINEAR ULTRASONIC WAVES

ABSTRACT

In a typical Whipple shield for protecting spacecraft from hypervelocity impact (HVI), the debris cloud, formed by the shattered material of the outer bumper layer, can commit multitudinous, disorderedly scattered pitting craters and cracks over a wide region in the rear wall layer. Pervasive but insidious, pitting damage typically features hundreds of small craters and cracks disorderedly clustered over a wide region, accompanying diverse microstructural damages. The pitting damage induces highly complex, mutually-interfering wave scattering in a linear regime, and triggers acoustic nonlinearity. In the pitted region the material plasticity and nonlinearity are remarkably intensified, and the contact acoustic nonlinearity (CAN) is introduced upon interaction between probing guided ultrasonic waves (GUWs) and pitting damage. Targeting at quantitatively evaluating the pitting damage, insight into the generation of high-order modes by pitting damage is achieved from the perspective of nonlinear GUV features. The theoretical analysis is validated via numerical simul

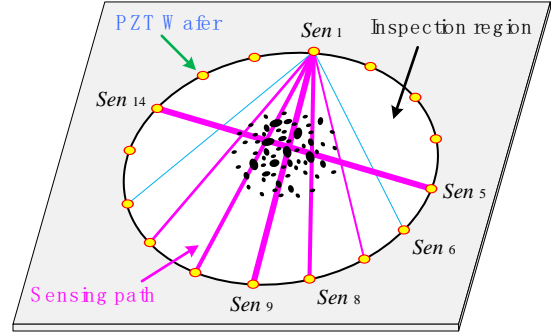
FIGURE 3: PZT NETWORK COVERAGE FOR NORMAL HVI-INDUCED PITTING DAMAGE CHARACTERIZATION

A built-in sensor network, comprising of sixteen miniaturized and lightweight PZT wafers (denoted by $Sen_i (i=1,2,\dots, 16)$) mounted on surface of the rear wall layer, is configured (see Figure 3). Each PZT is alternatively used as actuator and sensor, forming a pair of sensing paths covering the entire pitting damage region. Model pair S_0 - S_0 (0.9-1.8 MHz mm) with quasi phase-velocity matching are investigated to gain an insight into the accumulative nature of β' in the experiment. Covering the entire inspection region, each sensing path in the sensor network independently captures linear/nonlinear GUV features to calculate the damage index.

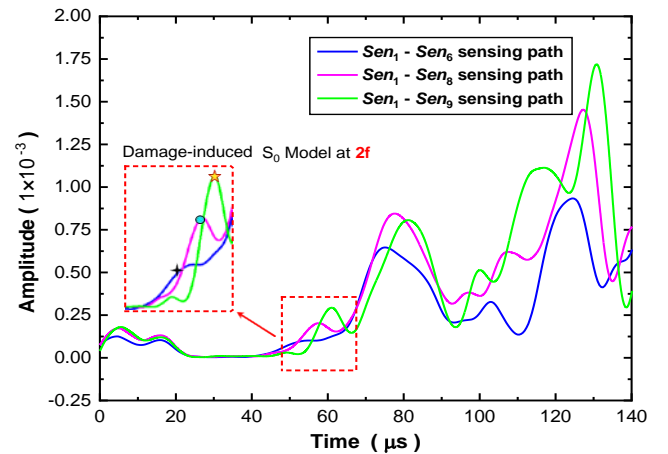
FIGURE 4: SPECTRUM AT DOUBLE EXCITATION FREQUENCY FOR REPRESENTATIVE SENSING PATHS

Figure 4 illustrates the second harmonic S_0 mode extracted from three representative sensing paths (*i.e.*, Sen_1 - Sen_9 , Sen_1 - Sen_8 and Sen_1 - Sen_6) traversing the inspection region, with more pitting craters and cracks in the sensing path, changes in second harmonic mode will be remarkably intensified, leading to higher damage index β' . Inversely, it is feasible to describe the pitting damage quantitatively in terms of variation in β' .
