## IN SITU THERMOGRAPHIC PROCESS MONITORING DURING AUTOMATED FIBER PLACEMENT

### ABSTRACT

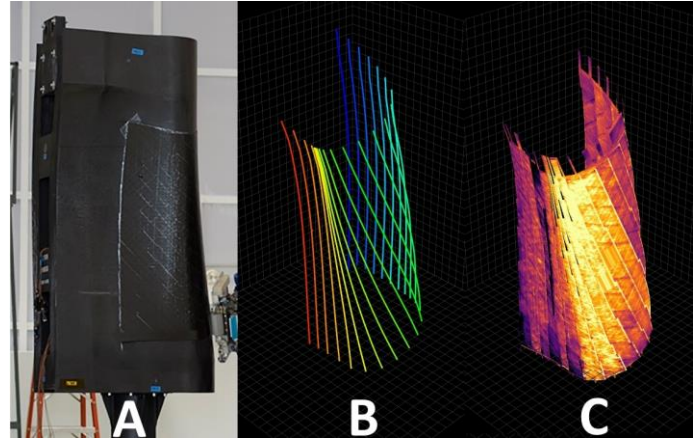
**FIGURE 3:** A) photo of the Complex Contour Tool B) image depicting the tool path for each course C) the 3D reconstruction of the ply layup thermal data

Using ISTIS we were able to observe inconsistencies in heating during a build on the Complex Contour Tool (CCT) shown in Figure 3a. These inconsistencies resulted from several factors, and ultimately correlated with the presence of manufacturing defects. In Figure 3c there is higher than average temperatures in a particular section of the CCT part. An examination of the course paths in Figure 3b shows that the narrowing of the course width meant that the heat lamp passed over this area repeatedly. In Figure 4, the darker (colder) regions of the part are the result of inadequate exposure to the heat lamp due to the complex geometries. These areas are correlated with peel up defects as a result of inadequate adhesion.
